Infrared Reflectance Imaging for Corrosion Inspection Through Organic Coatings (WP-0407)

13. SUPPLEMENTARY NOTES ASETSDefense 2009: Sustainable Surface Engineering for Aerospace and Defense Workshop, August 31 - September 3, 2009, Westminster, CO. Sponsored by SERDP/ESTCP.

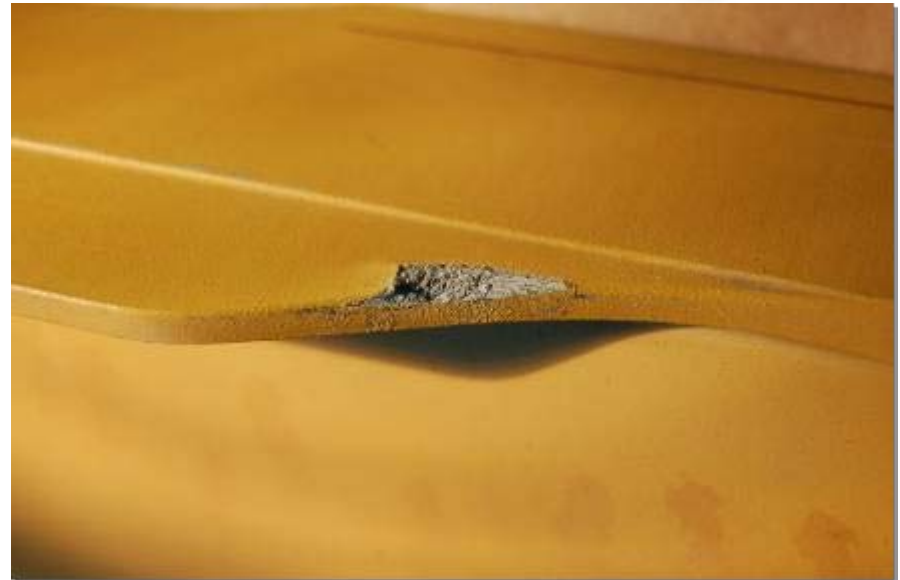
Mid-IR Inspection

Exfoliation Corrosion

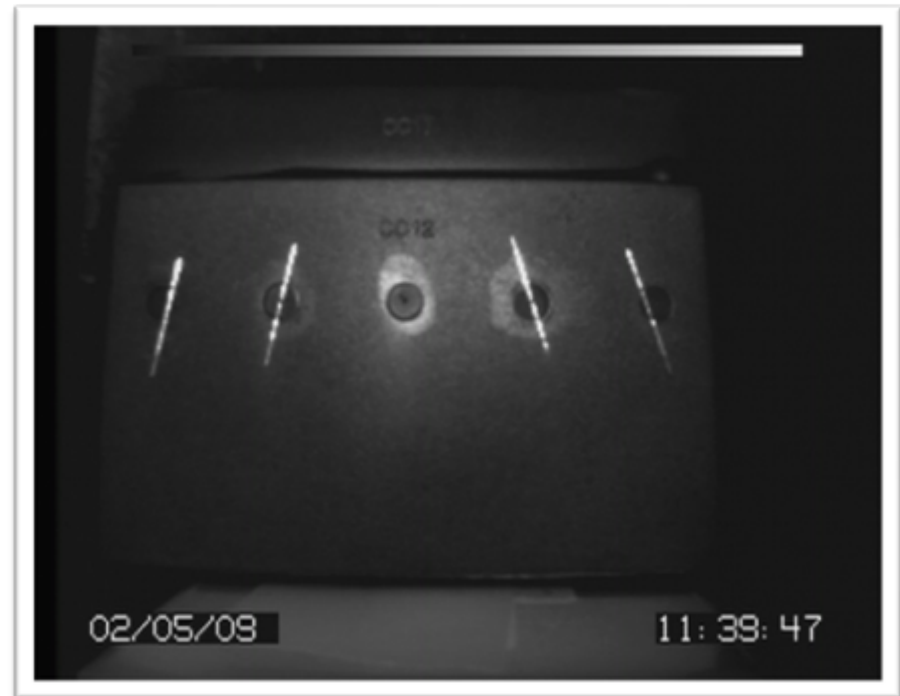
Fastener Panel Anomalies

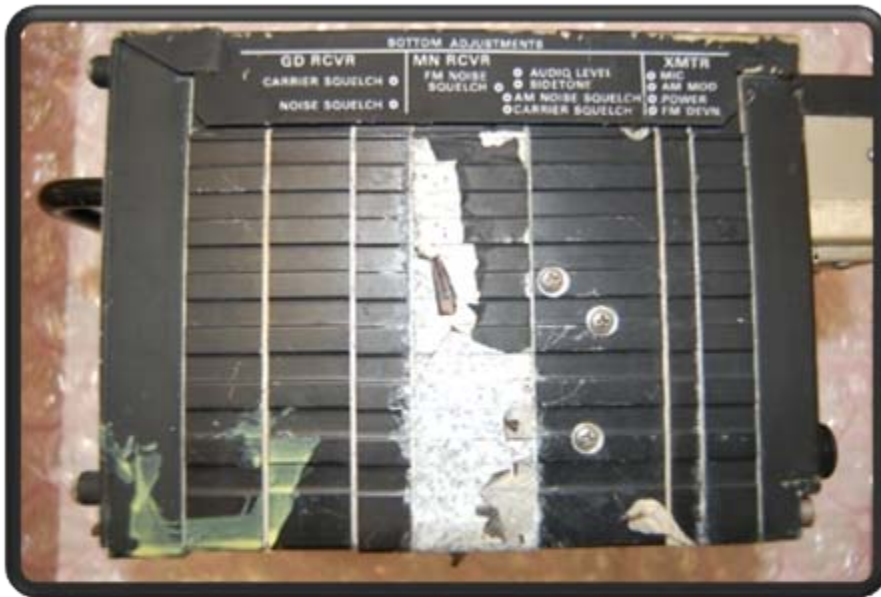
Visual Photograph

- Avionics Receiver/Transmitter – Evaluation of corrosion damage for root cause assessment.

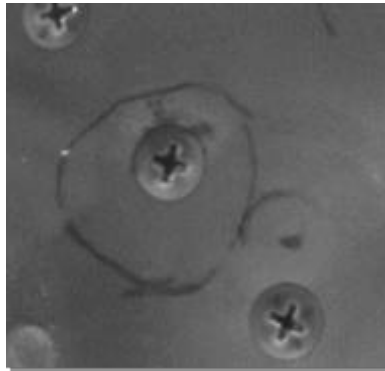
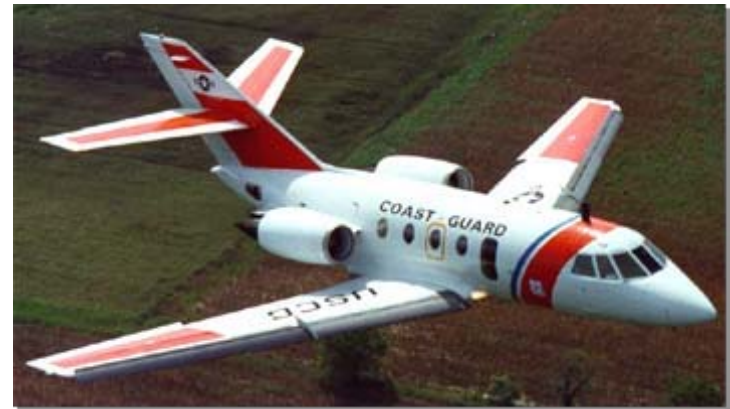
IR Image - Painted

Note: Several corroded areas were found while checking the scan rate on this region, all corroded areas found via the IRRIT were confirmed by chemically stripping.

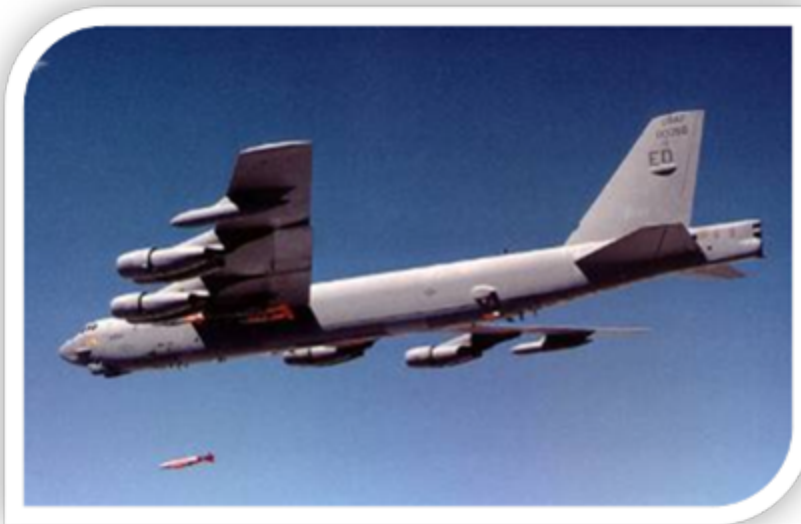
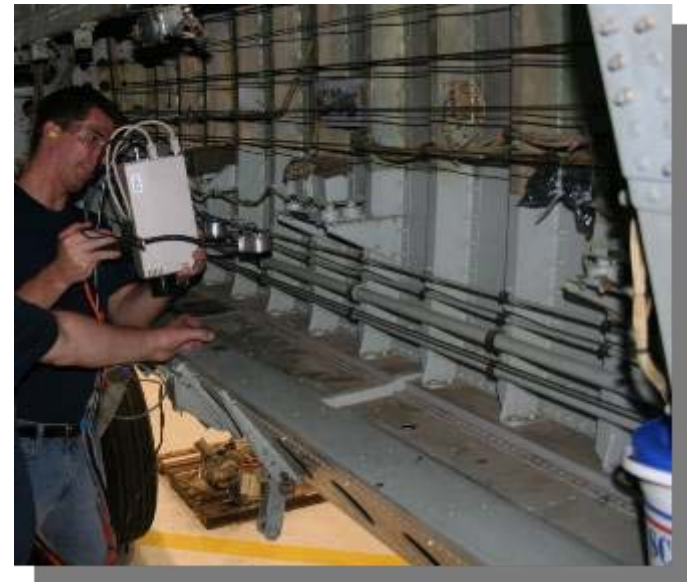
B-52 Demonstration

- *Surveyed Bomb Bay Longerons of (2) B-52 Aircraft at OC-ALC. Right and left sides inspected, each 15-16 feet in length.*
- *8 corrosion sites located via IR Inspection that were not identified through visible or eddy current inspection.*
- *All corrosion sites were confirmed following chemical spot stripping. 100% correlation achieved.*

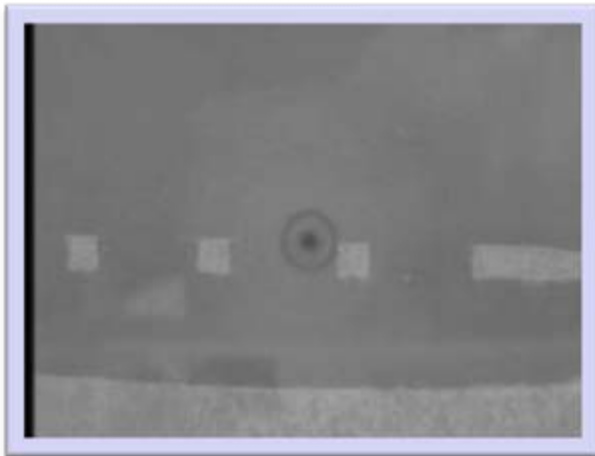
**Corrosion Product
White**

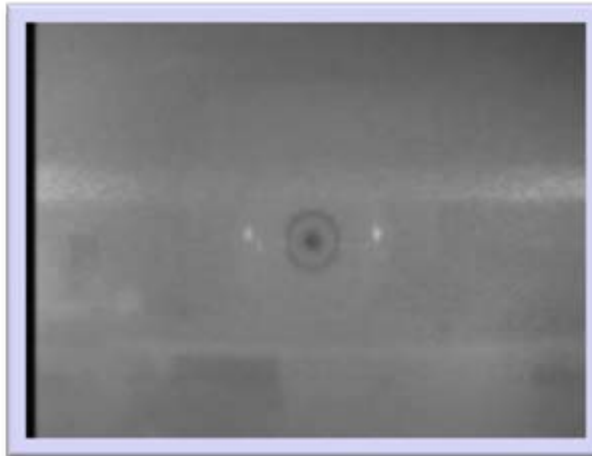
**No Corrosion Product
Observed**

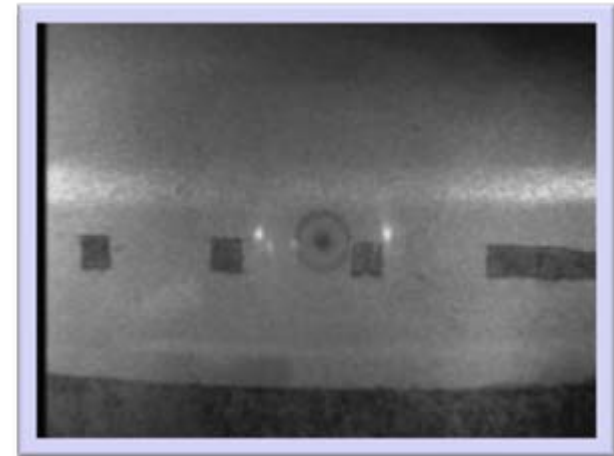
**Corrosion
Product Black**
